DELTA TUG & BARGE LTD. SALVAGES HISTORIC VESSEL LANGDALE QUEEN

By Capt. Don Rose

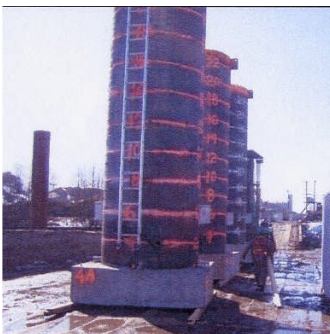
Photo #5:

Three tubes with concrete bases for stability were assembled on shore then lowered, secured and sealed on the deck. (See Photo #5). When the tubes were in place, divers went inside the tubes and cut openings in the deck to allow access to the hull. Nine pumps (three in each tube) each with a capacity of eighteen tons per minute were lowered through the tubes into the hull with their discharge lines coming up through the tubes. (See Photo #6)

Several options were explored for removing the water from the hull and floating her to the surface. These were dismissed for various reasons as not being practical, possible, or environmentally friendly. At 03:00 A.M. one morning, Mitch Hughes came up with the idea of placing large circular steel tubes on the deck that would protrude above the water surface and lowering pumps into the hull.

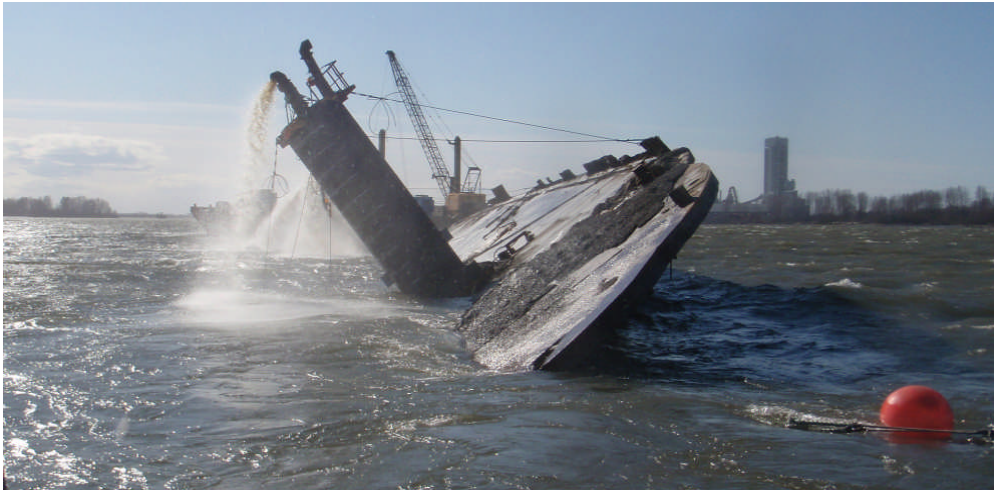
Photo #7: Mitch Hughes Photo

On the 31st of March 2009 the first salvage attempt was made. With the pumps operating she did come up to the surface. However, due to the poor stability of the vessel and the free surface effect of the water inside the hull she came to the surface with a heavy list to starboard. Realizing this was not going to work, the pumps were stopped and she settled back to the bottom. (See Photo #7)

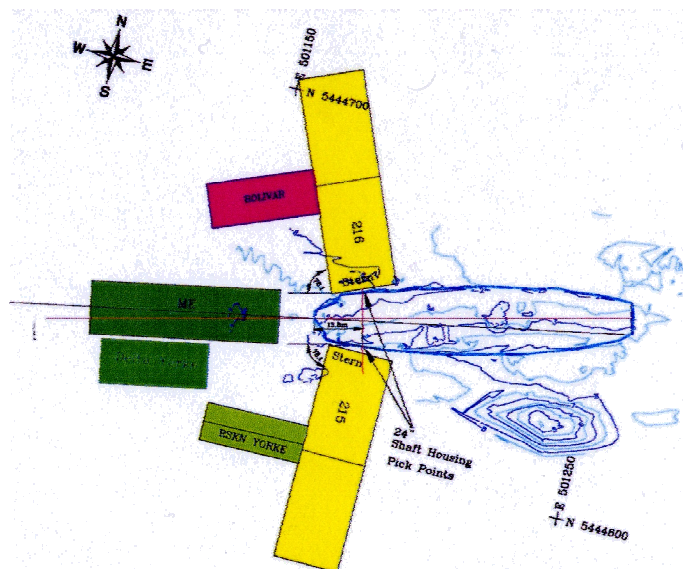
Concluding that the Langdale Queen had to be stabilized during the raising, the following procedure was put into action. Two barges were outfitted with rod jacks capable of lifting five hundred tons each. The barges were positioned transversely on each side at the stern of the Langdale Queen. The rod jacks were attached by cables to the tail shafts on each side of the vessel. (See drawing)

Drawing showing position of barges at stern of the Langdale Queen.
Drawing courtesy of Mitch Hughes

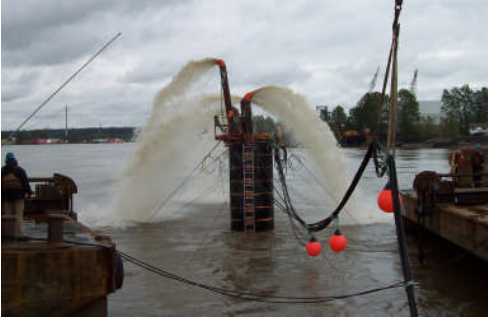
Photo #8 Mitch Hughes Photo

At the start of the procedure, the pumps were turned on in a specific order and the rod jacks were used to raise the stern of the Langdale Queen to the surface. Once the stern was raised above the surface, all the pumps were engaged, which brought the remainder of the vessel to the surface. (See Photos 8, 9 & 10)

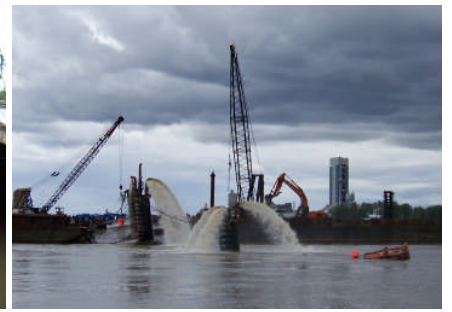
Photo #10 Don Rose Photo

The pumps at the aft end of the vessel were started first, at the same time the starboard barge took up to one hundred and fifty tons of strain with the port barge taking twenty tons of strain. The forward end to the Langdale Queen was attached to a buoy (See Photo #10) with a 1000 horsepower tug standing by to provide assistance as required.

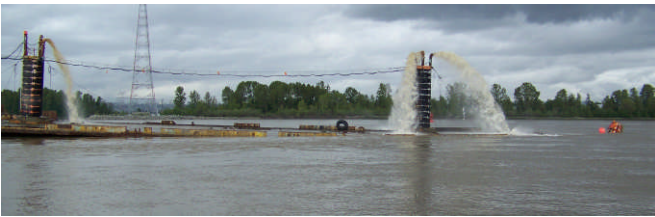
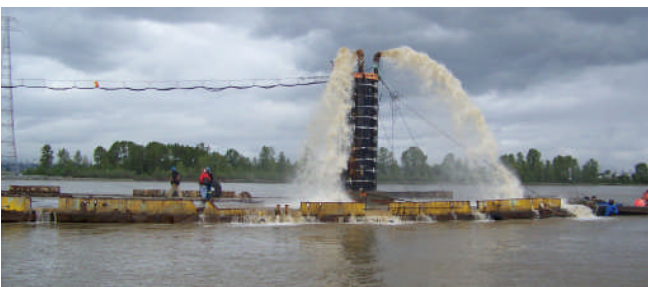
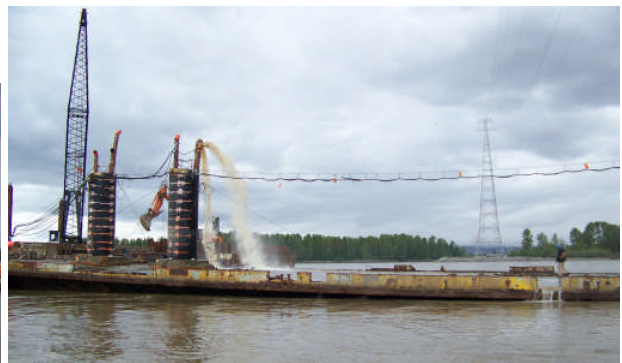
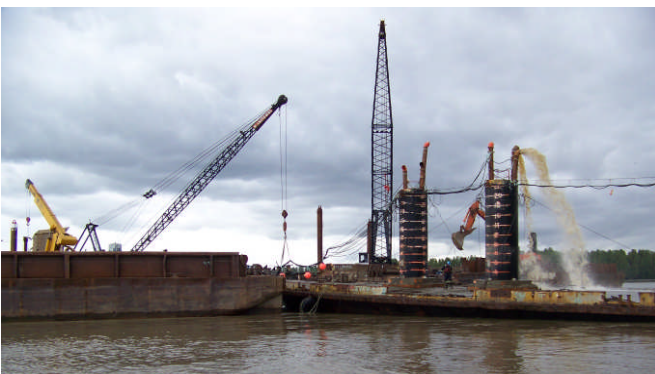
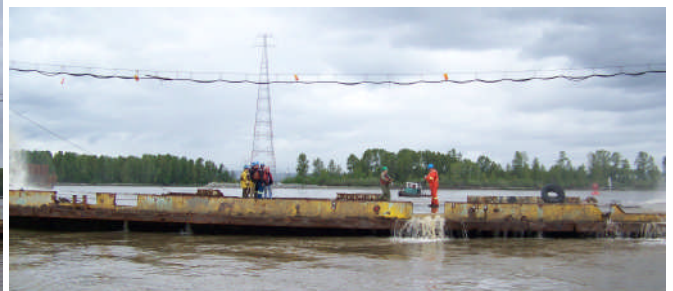
I had the opportunity to observe the Langdale Queen come to the surface. Although to a non mariner it may not appear to be very exciting, there were some very tense moments as the one hundred and six year old vessel came to the surface. At first the stern came up, then the bow came up and broke the surface. The following series of photos that I took speak for themselves as they show the historic Langdale Queen coming to the surface.
